Re: Results of Leachate Seep Investigation  
South Dayton Dump and Landfill Site Moraine, Ohio (Site)

**LEACHATE SEEP INVESTIGATION - SEPTEMBER 2008  
SOUTH DAYTON DUMP AND LANDFILL SITE  
Moraine, Ohio**

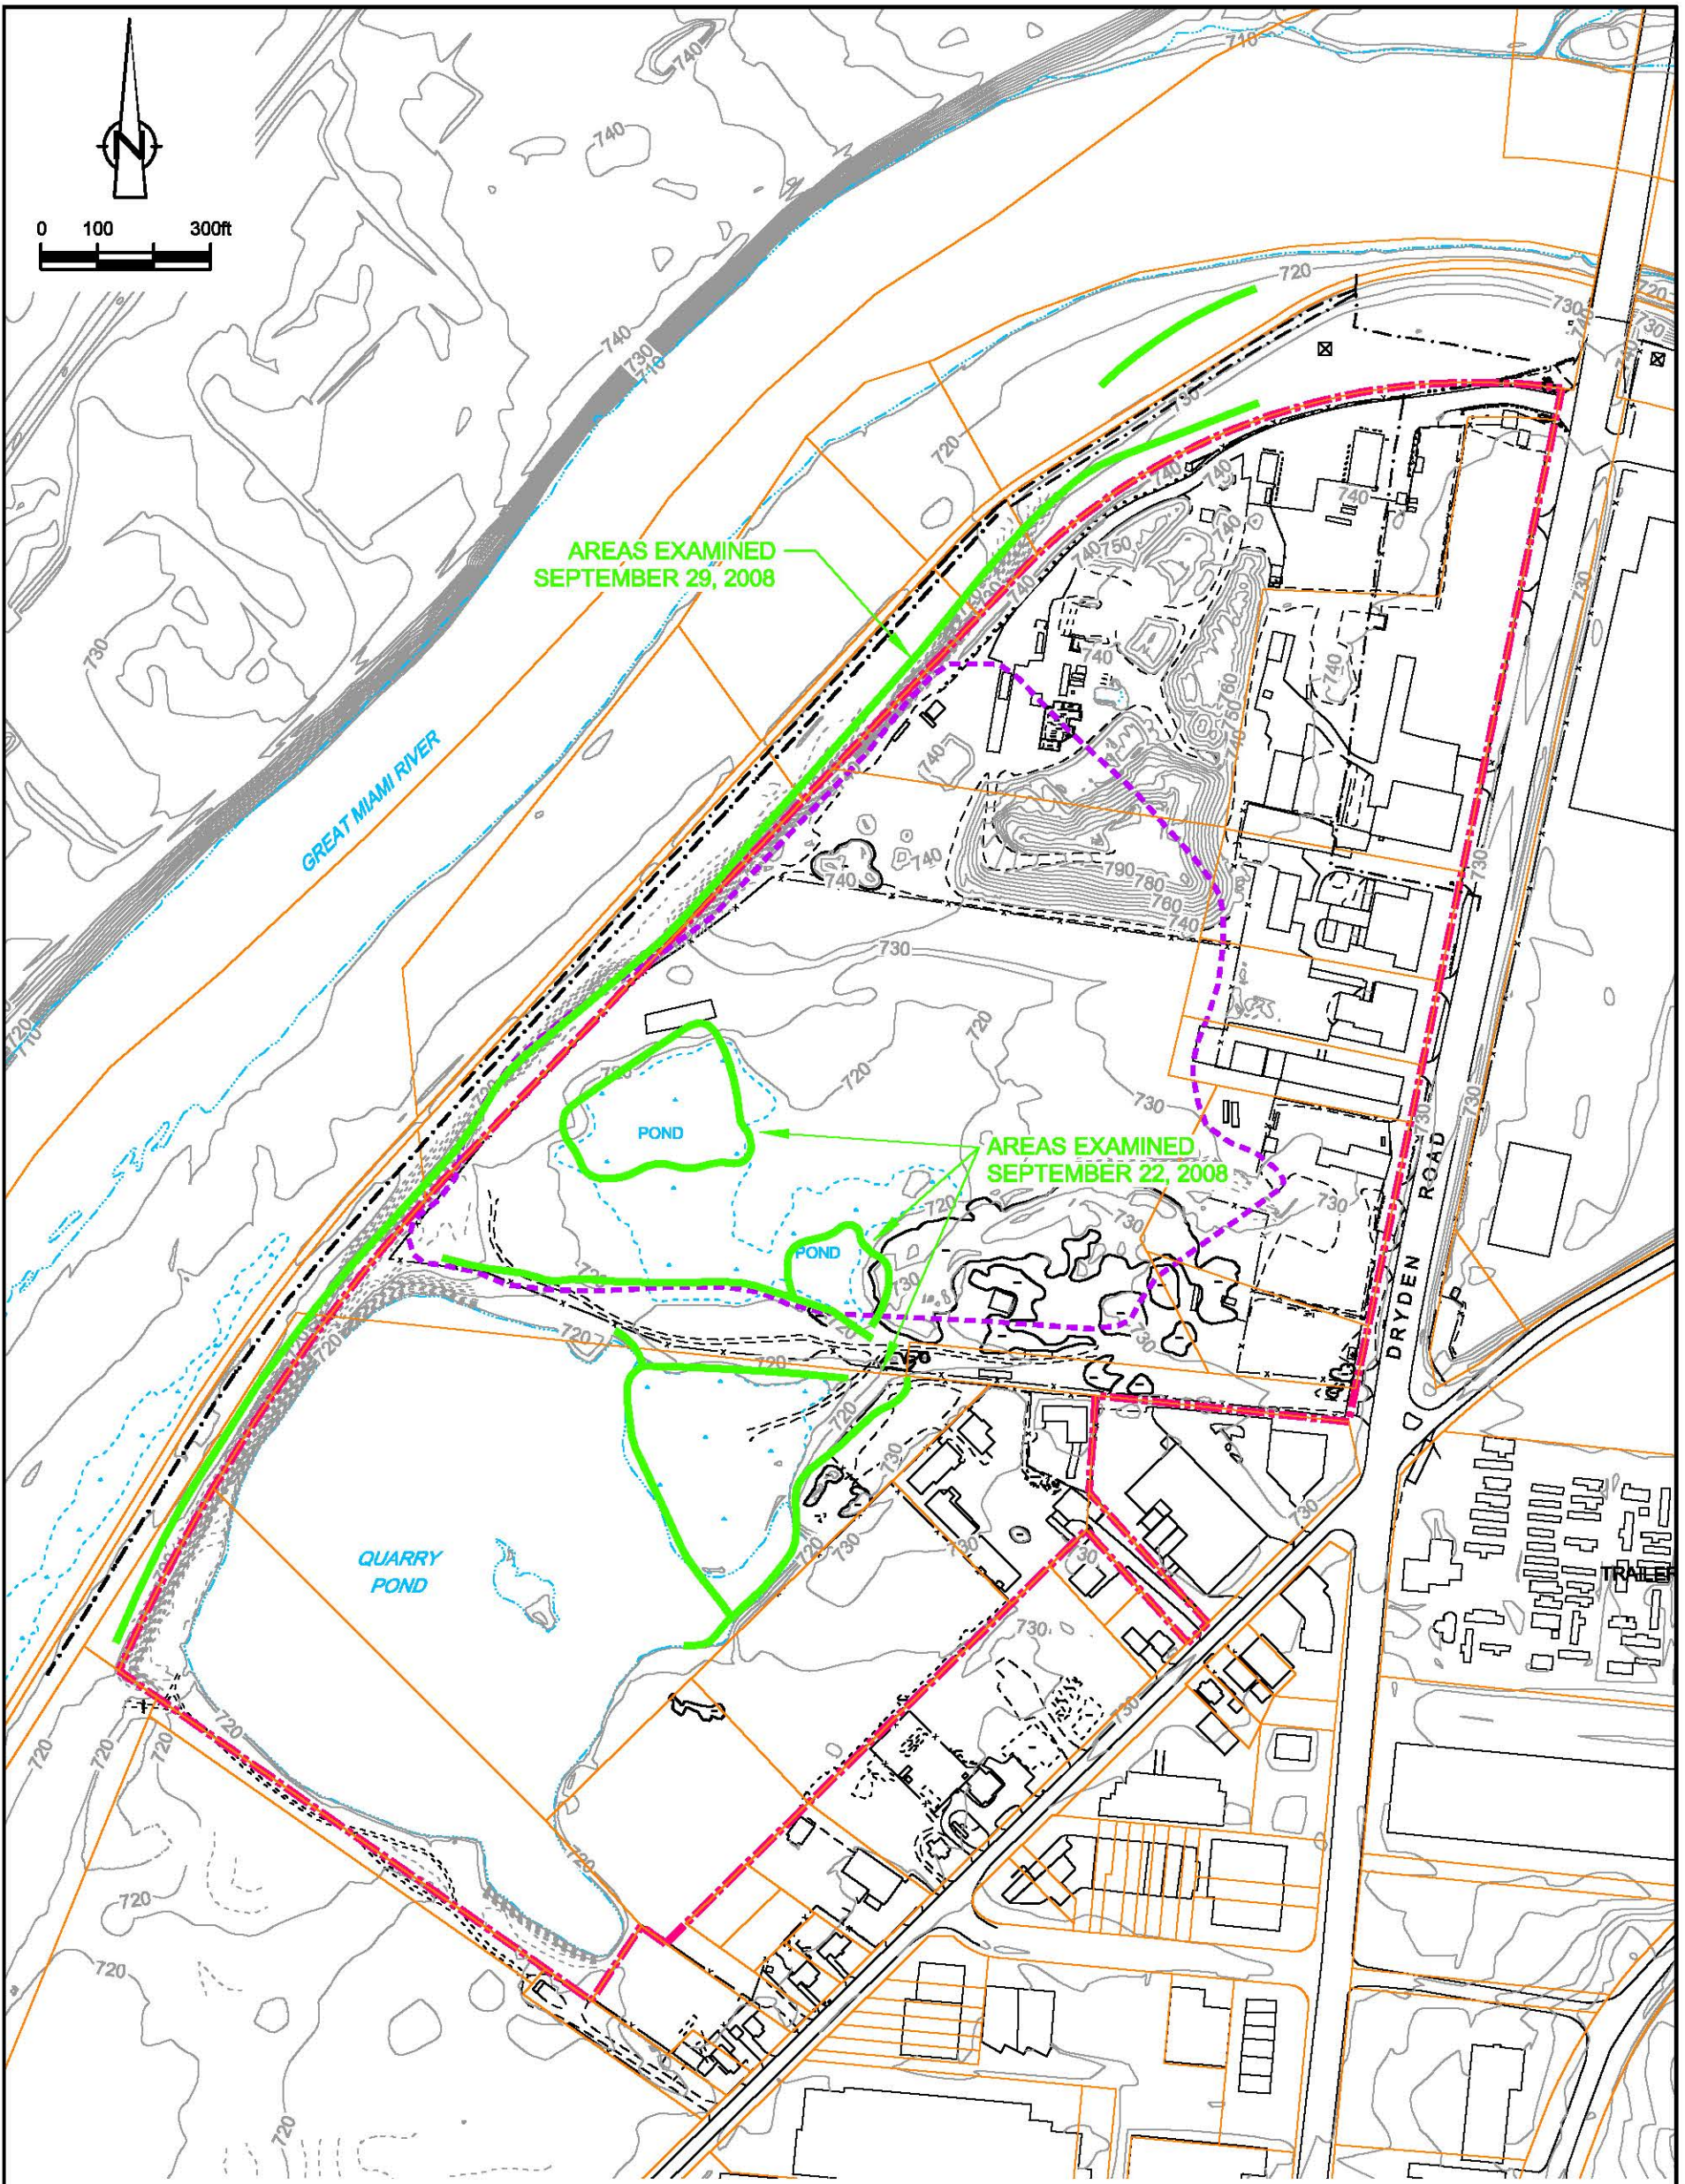
figure 1

A Site Plan showing the area surveyed during the Leachate Seep Investigation is provided on Figure 1.
